Manhole Inspection Summary

Manhole # S23GG_055MH

Insp Date: **10/3/07 10:31 AM**

Location Address: **1431 CAREY ST**

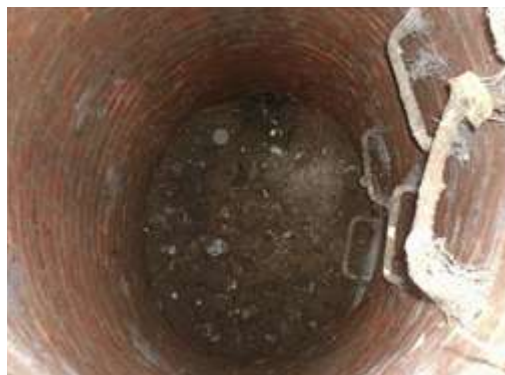
Top View

Infiltration: ☐ None ☐ Joint ☐ Cracks ☐ Mortar ☐ Roots ☒ **Wall**

☒ **Debris** (not Condition related)

Steps Count: **6** Missing: **0** ☒ **Corroded**

Barrel infiltration. Corroded steps.
Channel debris.

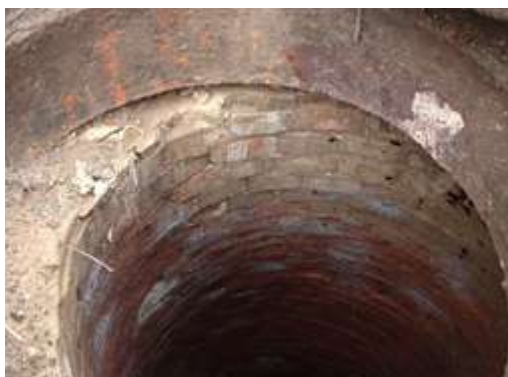
Defect

Frame Offset: **3** (in.)

☒ **Leaks**

Condition: ☐ Sound ☐ Cracked ☐ Root Intrusion ☐ Loose Brick ☒ **Deteriorated**

Infiltration: ☐ None ☒ **Joint** ☐ Cracks ☒ **Mortar** ☐ Roots ☐ Wall

Frame leaks. Frame offset. Adjustment
deterioration and infiltration - other side.

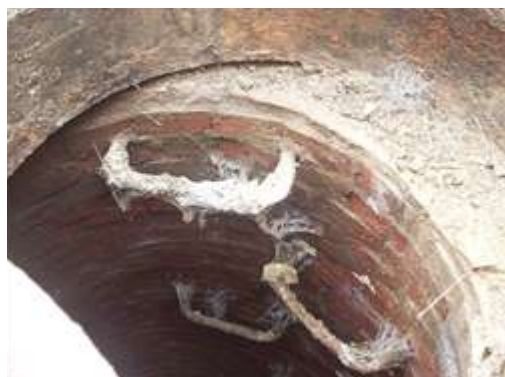
Defect

Frame leaks. Frame offset. Adjustment
deterioration and infiltration.

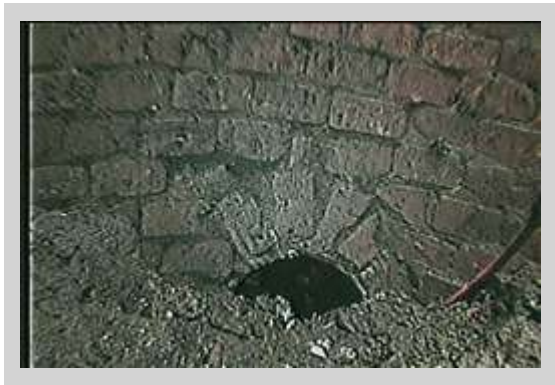
10 in. Circular Gravity Sewer
Pipe Out @ 12 O'Clock

Deposits: ☐ None ☒ **Mud** ☐ Sludge ☒ **Debris** ☐ Grease

Silt Depth: **4** (in.) Deposits Extent: **Medium**
